SANDYVILLE, W. VA.
NW 1/4 RIPLEY 15' QUADRANGLE
N3852.5—W8137.5/7.5

LANDSLIDES AND RELATED FEATURES

OF THE SANDYVILLE, W.VA. QUADRANGLE

OPEN FILE MAP 83-80 (H-3)

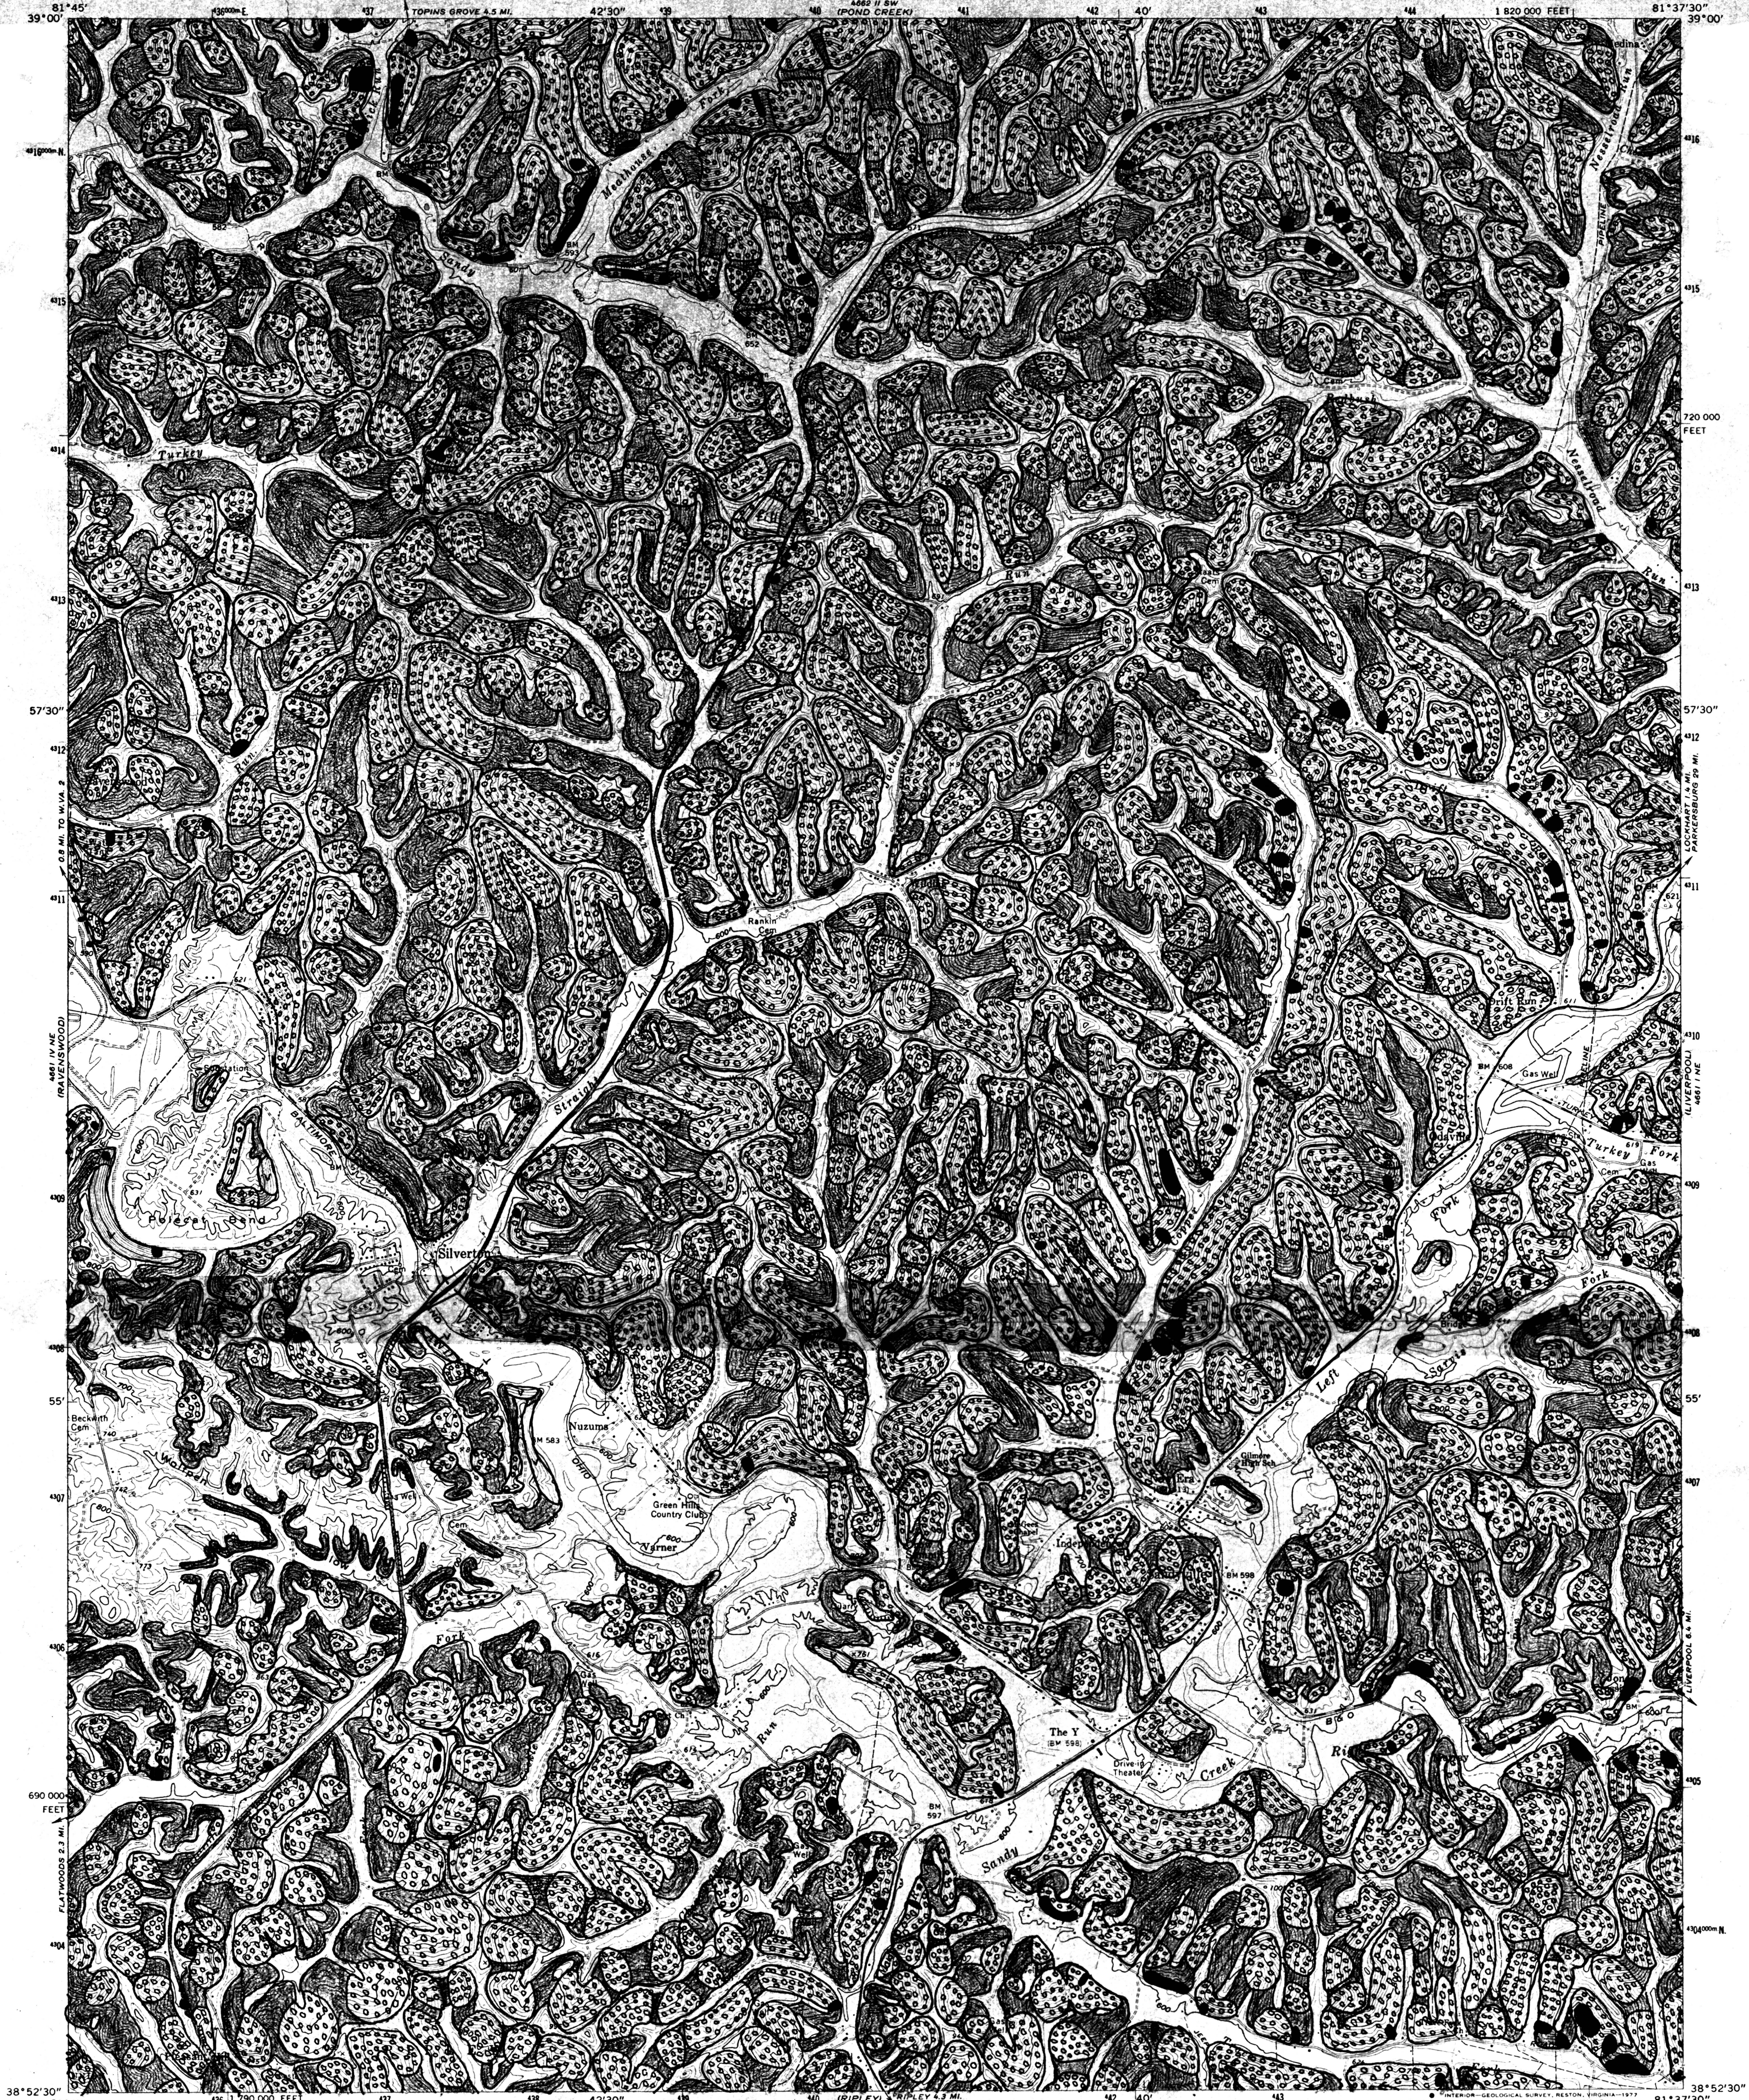
ACTIVE OR RECENTLY ACTIVE LANDSLIDE
Complex landslide composed of earthflow, debris
slide, earth and rock slump. Identified from
historical records, and from scars, debris and
other field evidence. Ground extremely unstable,
sliding accelerated by excavation, loading and
changes in drainage conditions. May include
areas with several active slides too small to
be shown separately.

OLD LANDSLIDE
Area of extensive hummocky ground caused by
earthflow and earth and rock slump. Lacks
clear evidence of active sliding. Relatively
stable in natural, undisturbed state,
generally not affected by small structures properly
sited in areas away from the edge of the toe,
can be reactivated by extensive, rapid exca-
vation, loading, and changes in ground water and
surface water conditions. Area of old landslide
probably includes recent ones not identified
from field evidence or otherwise documented.
Upslope boundary of landslide generally defined
by modified scarp, but downslope (toe) may be
gradational and not well defined.

COLLUVIAL SLOPE
Valley wall along major streams with slope as
steep as 40° (85%), stony, clayey silt soil up
to 50 ft. (15 m) thick; commonly buttressed by
a terrace or bench at the toe of the slope, very
susceptible to sliding by cutting of toe area,
removal of terrace or bench, and overloading;
slide commonly activated without apparent cause.

**AREAS SUSCEPTIBLE TO DEBRIS FLOWS AND DEBRIS
AVALANCHES**
Primarily shallow, narrow ravines and chutes with
accumulation of stony colluvium generally 10 ft.
(3 m) or less in thickness; susceptible to rapid
movement during intense rainfall. Most ravines
and chutes designated show evidence of former
debris flows and avalanches. Symbol-2 design-
ates historical debris flow or debris avalanche.

AREAS SUSCEPTIBLE TO ROCKFALL
Steep, locally vertical, natural and man-made
slopes and cliffs, 15 ft. (4.5 m) or more high;
formed dominantly of sandstone, limestone, sandy
shale, mudstone and claystone. Interbedded mud-
stone, claystone and shale weather rapidly leaving
sandstone and limestone rock faces unsupported.

SOIL AND ROCK SUSCEPTIBLE TO LANDSLIDING
Soil and rock similar to that involved in land-
slides elsewhere in map area; primarily areas
underlain by claystone, mudstone and shale
associated with other rock types. Rock weathers
rapidly on exposure forming clayey soil highly
susceptible to sliding. Includes coves (U-shaped,
shallow valleys) containing thick layers of clayey
soil that are very susceptible to sliding where
excavation breaks continuity of slope and where
overloaded by artificial fill.

AREAS LEAST PRONE TO LANDSLIDES
Map areas in which no patterns or symbols are shown,
primarily valley floors, ridge tops and broad
benches; modification by excavation and fill may
lead to local landslides.

Landslides and related features interpreted
from aerial photographs:
1:60,000 SCALE BLACK AND WHITE 1960
1:125,000 SCALE COLOR INFRARED 1973
1:80,000 SCALE BLACK AND WHITE 1975

Photointerpretation and field check 1978.
This map has not been edited or reviewed
for conformity with Geological Survey
standards and nomenclature.
